Technical Report
R 711S

March 1978

PROTECTIVE COATINGS FOR STEEL PILING:
ADDITIONAL DATA ON HARBOR EXPOSURE
OF TEN-FOOT SIMULATED PILING

Robert L. Alumbaugh, PhD and A. F. Curry

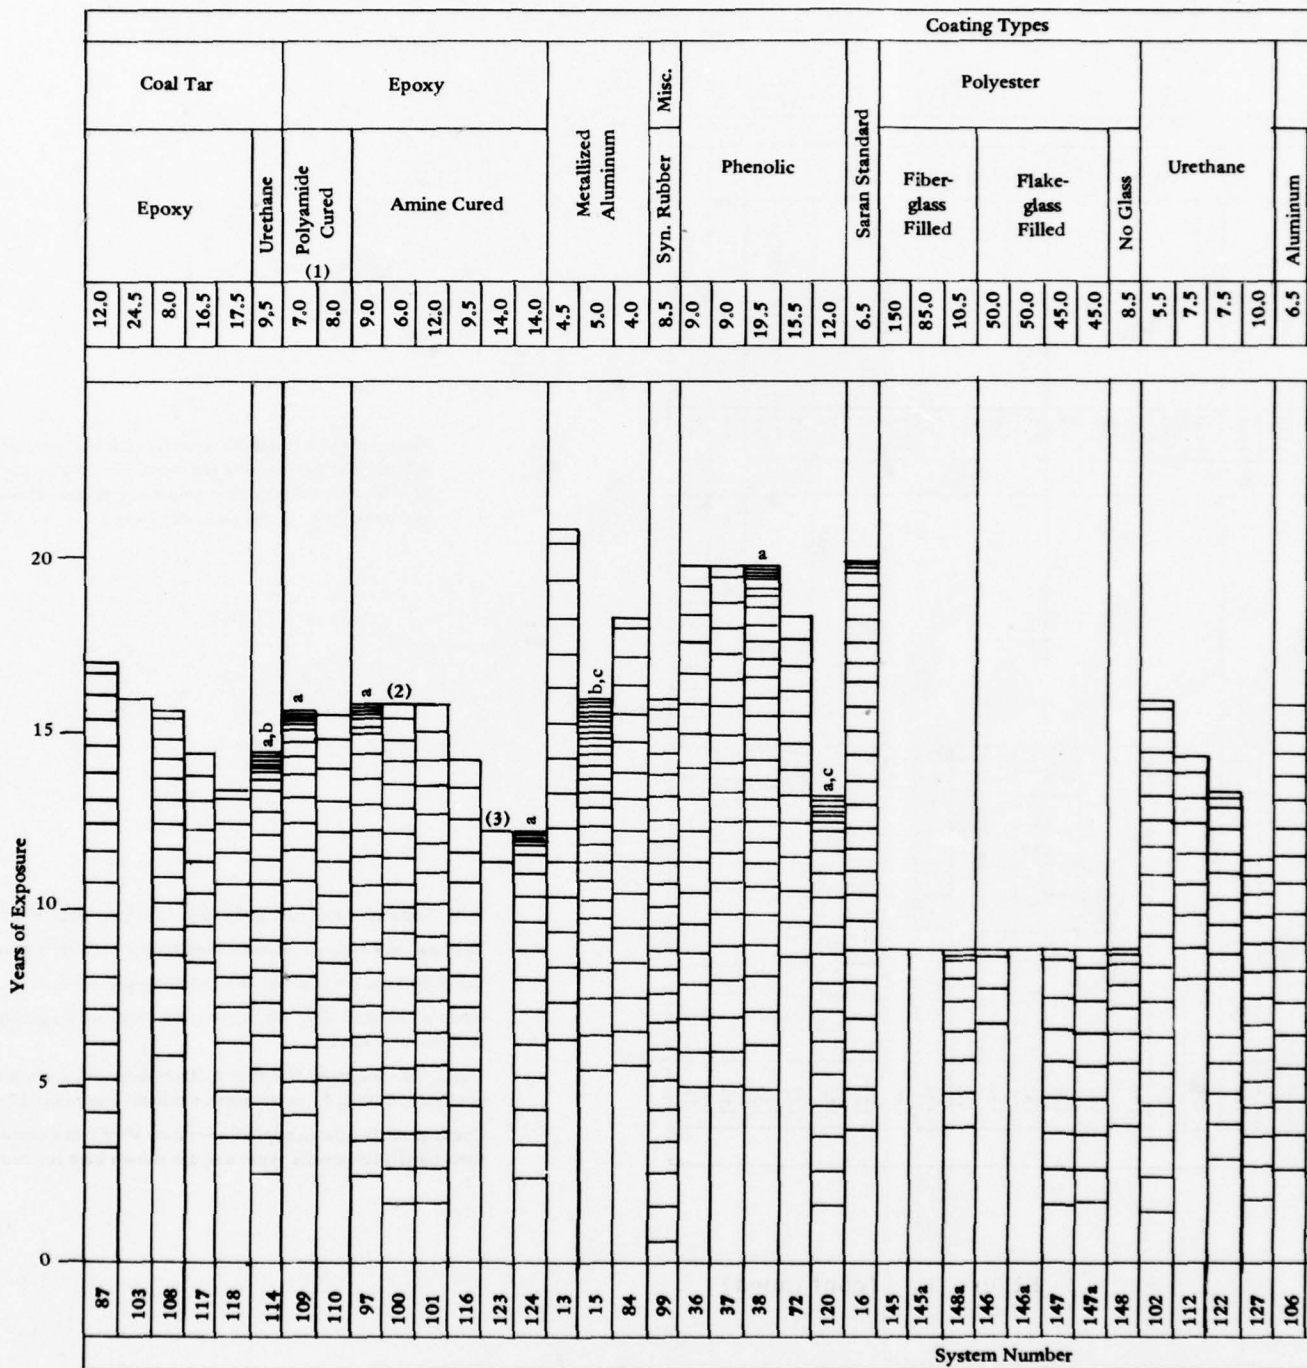
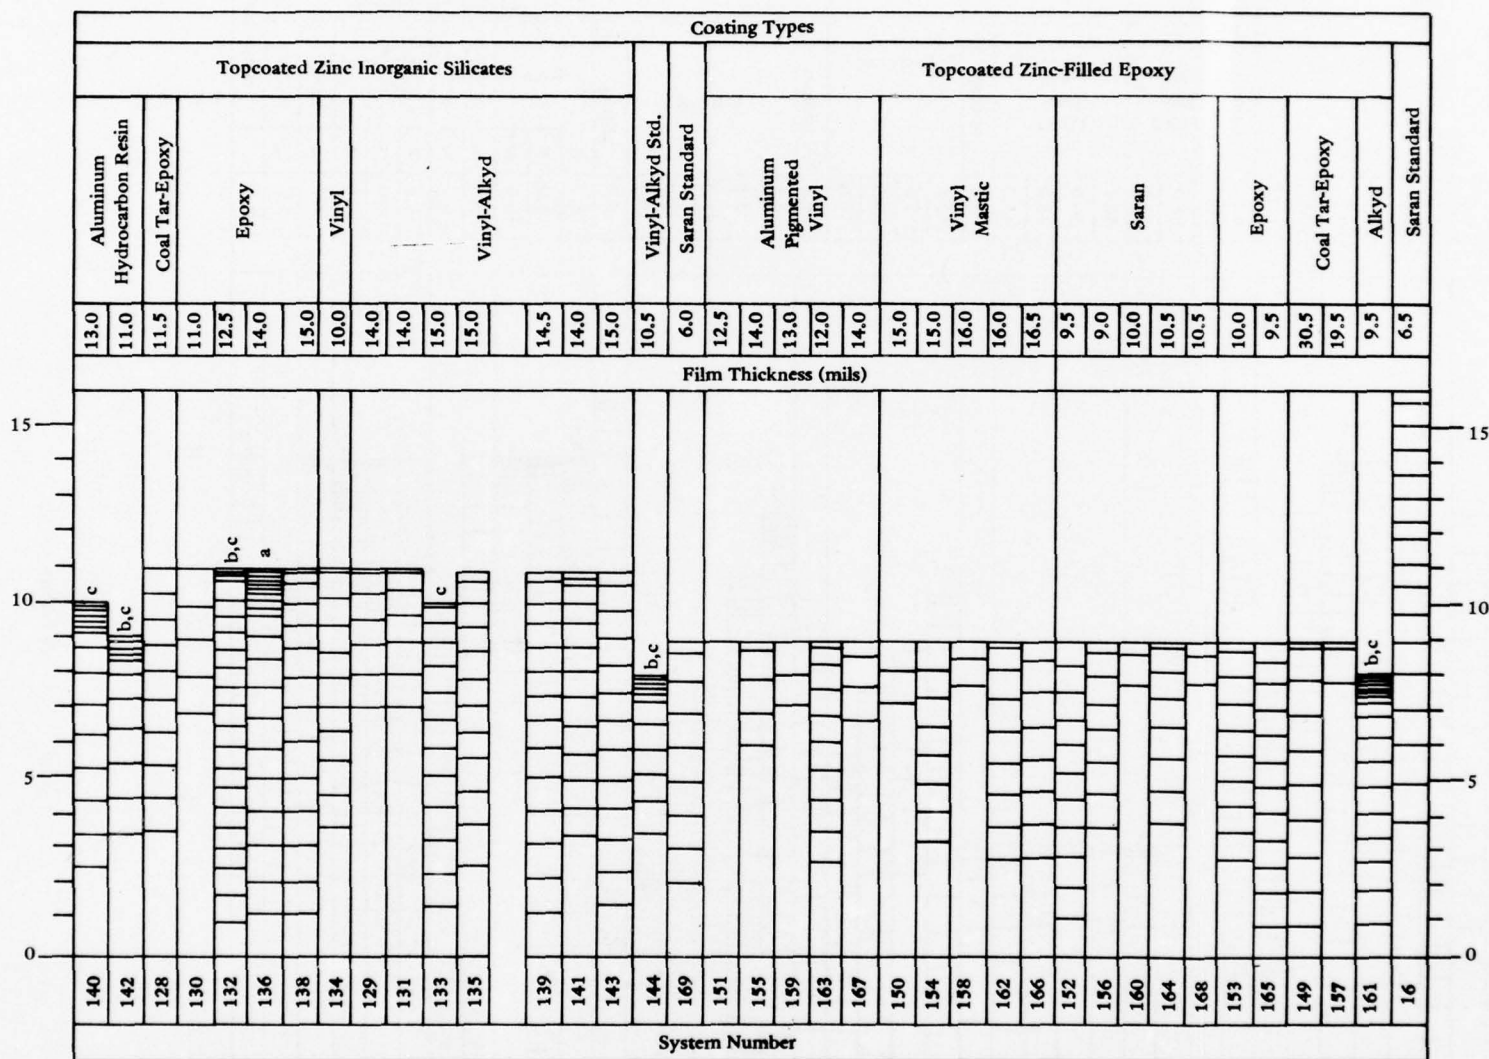
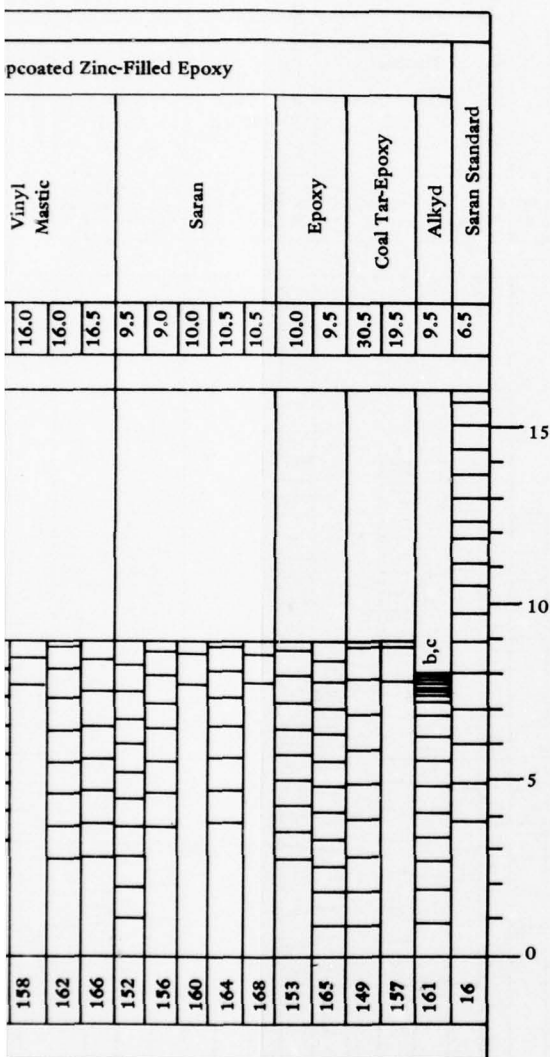
Figure 1. Comparative protection provided to corrosion dock panels by the

In Figure 1, the degree of system deteriorating or failure is denoted by a series of parallel lines within the bar. If the system was providing complete protection, the bar is only an outline. Within a given bar, and thus in a given system, the first line from the baseline of the graph indicates the approximate time of initial system deterioration (rusting). As the system deteriorates, the lines within the bar become progressively closer together; a completely darkened area at the end of the bar represents failure and removal of the system from exposure. It should be noted that, if a system provided relatively good protection to the panel, the spacing between the end of the bar graph and the line immediately next to it is not significant. Zones in which failure occurred are listed at the top of the bar graph for the corrosion dock panels.

(Complete protection denoted by outlined bar; initial system deterioration indicated by line nearest the baseline of the graph. As system deteriorates, lines become progressively closer together until they coalesce at failure and removal of the system from exposure.)
